Manhole Inspection Summary

Manhole # S29QQ_020MH

Location Address: **2701 FALLS RD**

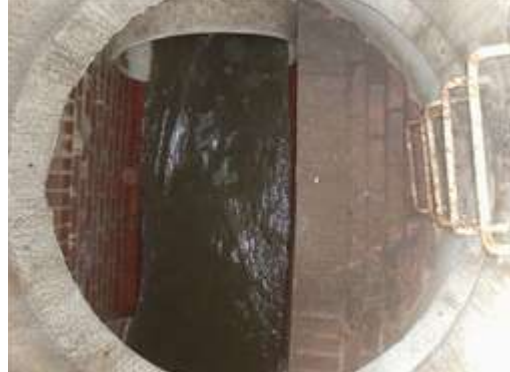
Top View

Bench debris.

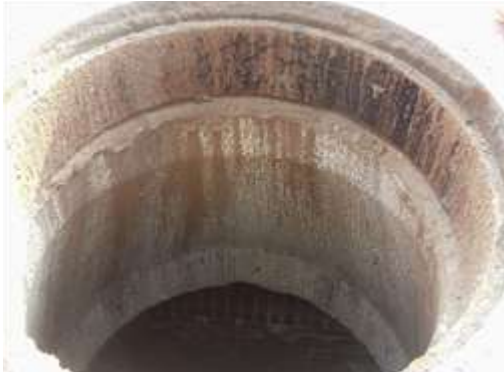
Defect

Frame leaks. Adjustment infiltration - other side.

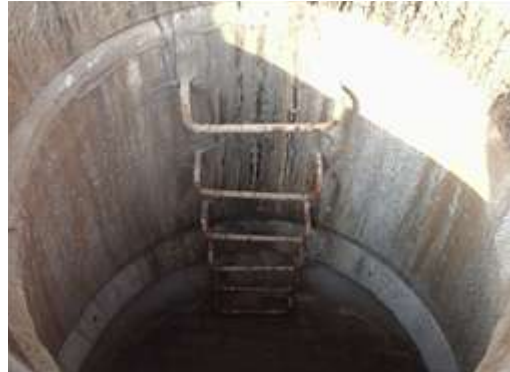
Defect

Frame leaks. Adjustment infiltration.

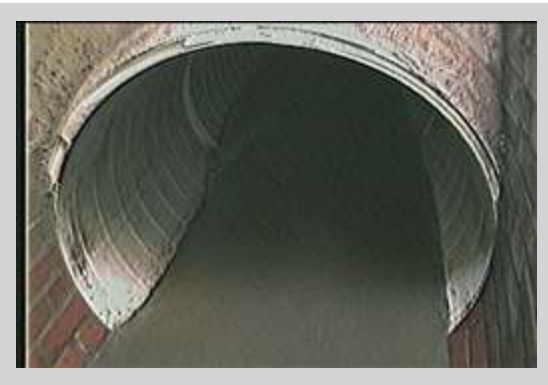
36 in. Circular Gravity Sewer Pipe Out @ 12 O'Clock

Pipe Material: **Unknown** ☐ Pipe Lined

Invert Depth: **10.95** (ft.) Flow Characteristics: **Fast**

Deposits: ☒ None ☐ Mud ☐ Sludge ☐ Debris ☐ Grease

Infiltration: **None** Pipe Seal Cond: **Unknown**

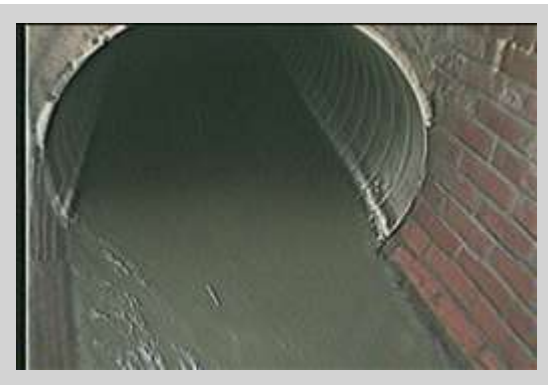
36 in. Circular Gravity Sewer Pipe In @ 6 O'Clock

Pipe Material: **Unknown** ☐ Pipe Lined

Invert Depth: **10.65** (ft.) Flow Characteristics: **Fast**

Deposits: ☒ None ☐ Mud ☐ Sludge ☐ Debris ☐ Grease

Infiltration: **None** Pipe Seal Cond: **Unknown**
